Tragedies that Forever Changed Safety In The Workplace

A. Ken Brooks Jr., CSP, CFPS
Insurance Planning, Inc.

DEADLIEST WORKPLACE ACCIDENTS TIMELINE

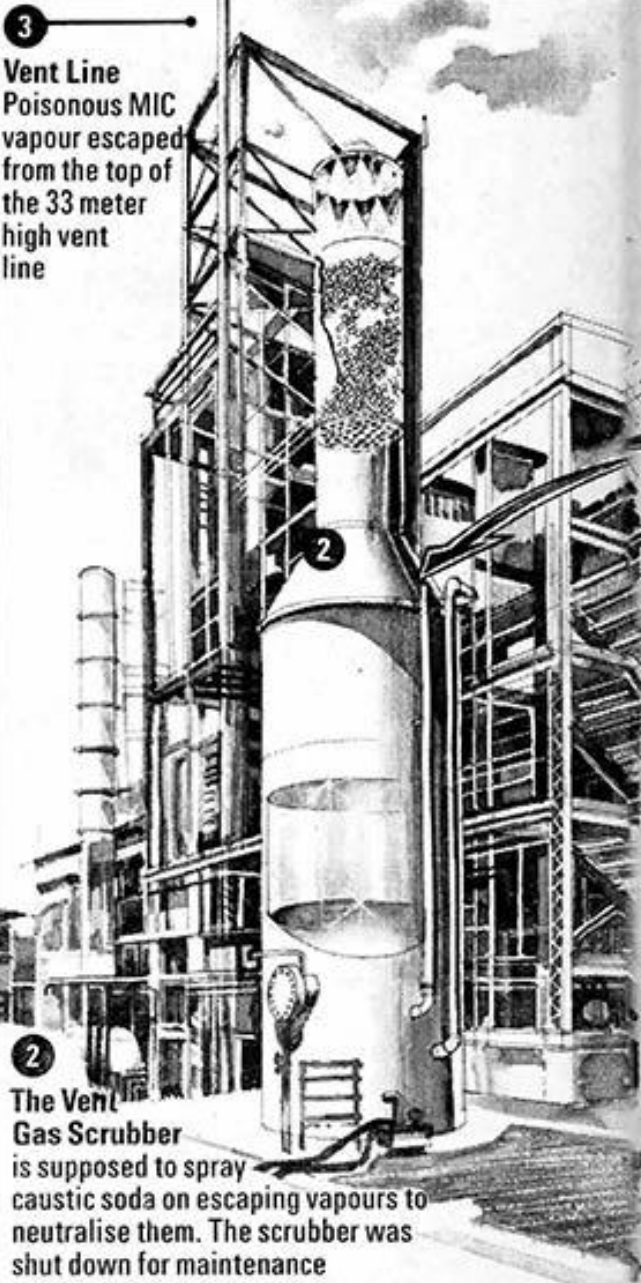
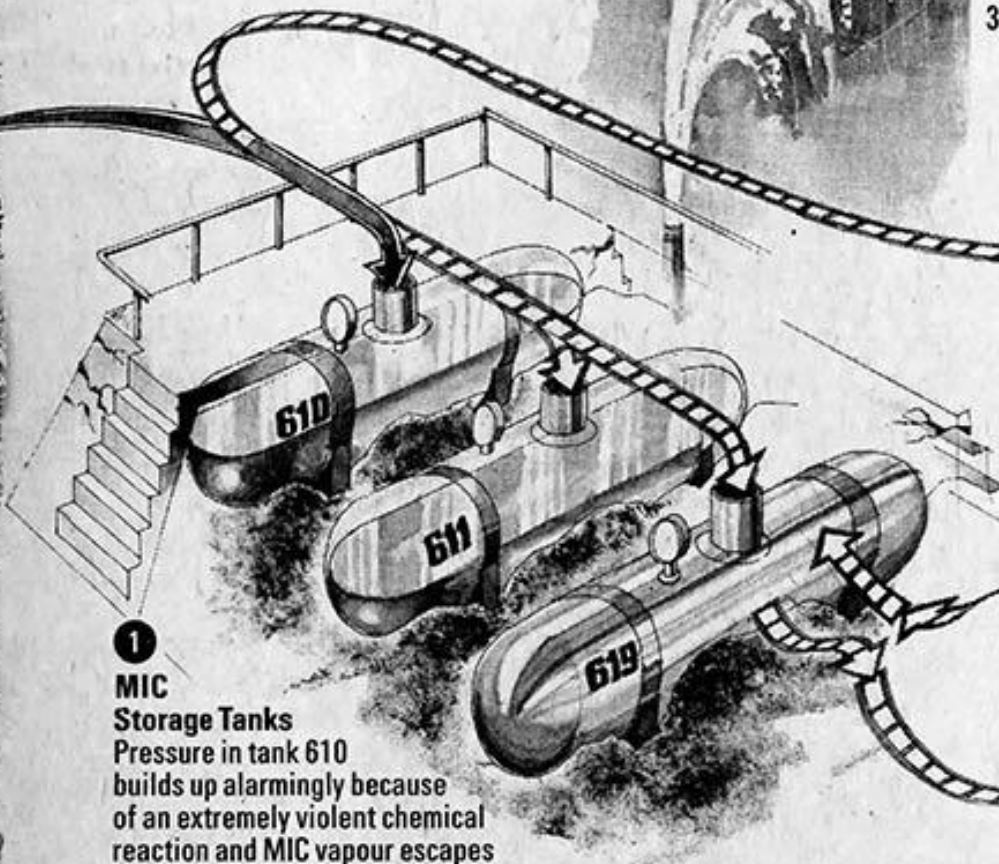
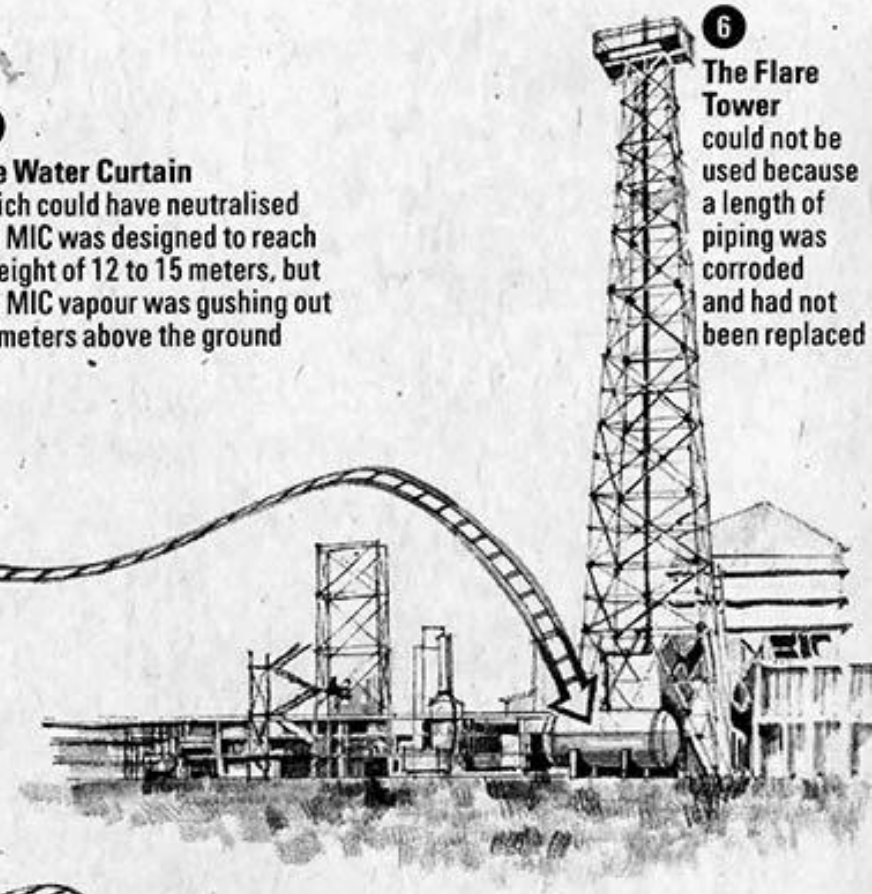
The Fail-Safe Failure

3 Vent Line
Poisonous MIC vapour escaped from the top of the 33 meter high vent line

2 The Vent Gas Scrubber is supposed to spray caustic soda on escaping vapours to neutralise them. The scrubber was shut down for maintenance

1 MIC Storage Tanks
Pressure in tank 610 builds up alarmingly because of an extremely violent chemical reaction and MIC vapour escapes rupturing a safety disc and popping the safety valve. Tank 619 was empty but nobody opened the valves between the two tanks to relieve pressure in 610.

5 The Water Curtain which could have neutralised the MIC was designed to reach a height of 12 to 15 meters, but the MIC vapour was gushing out 33 meters above the ground

6 The Flare Tower could not be used because a length of piping was corroded and had not been replaced

4 The Refrigeration System keeps MIC cool but was out of commission and tank 610 could not be cooled to slow down the reaction

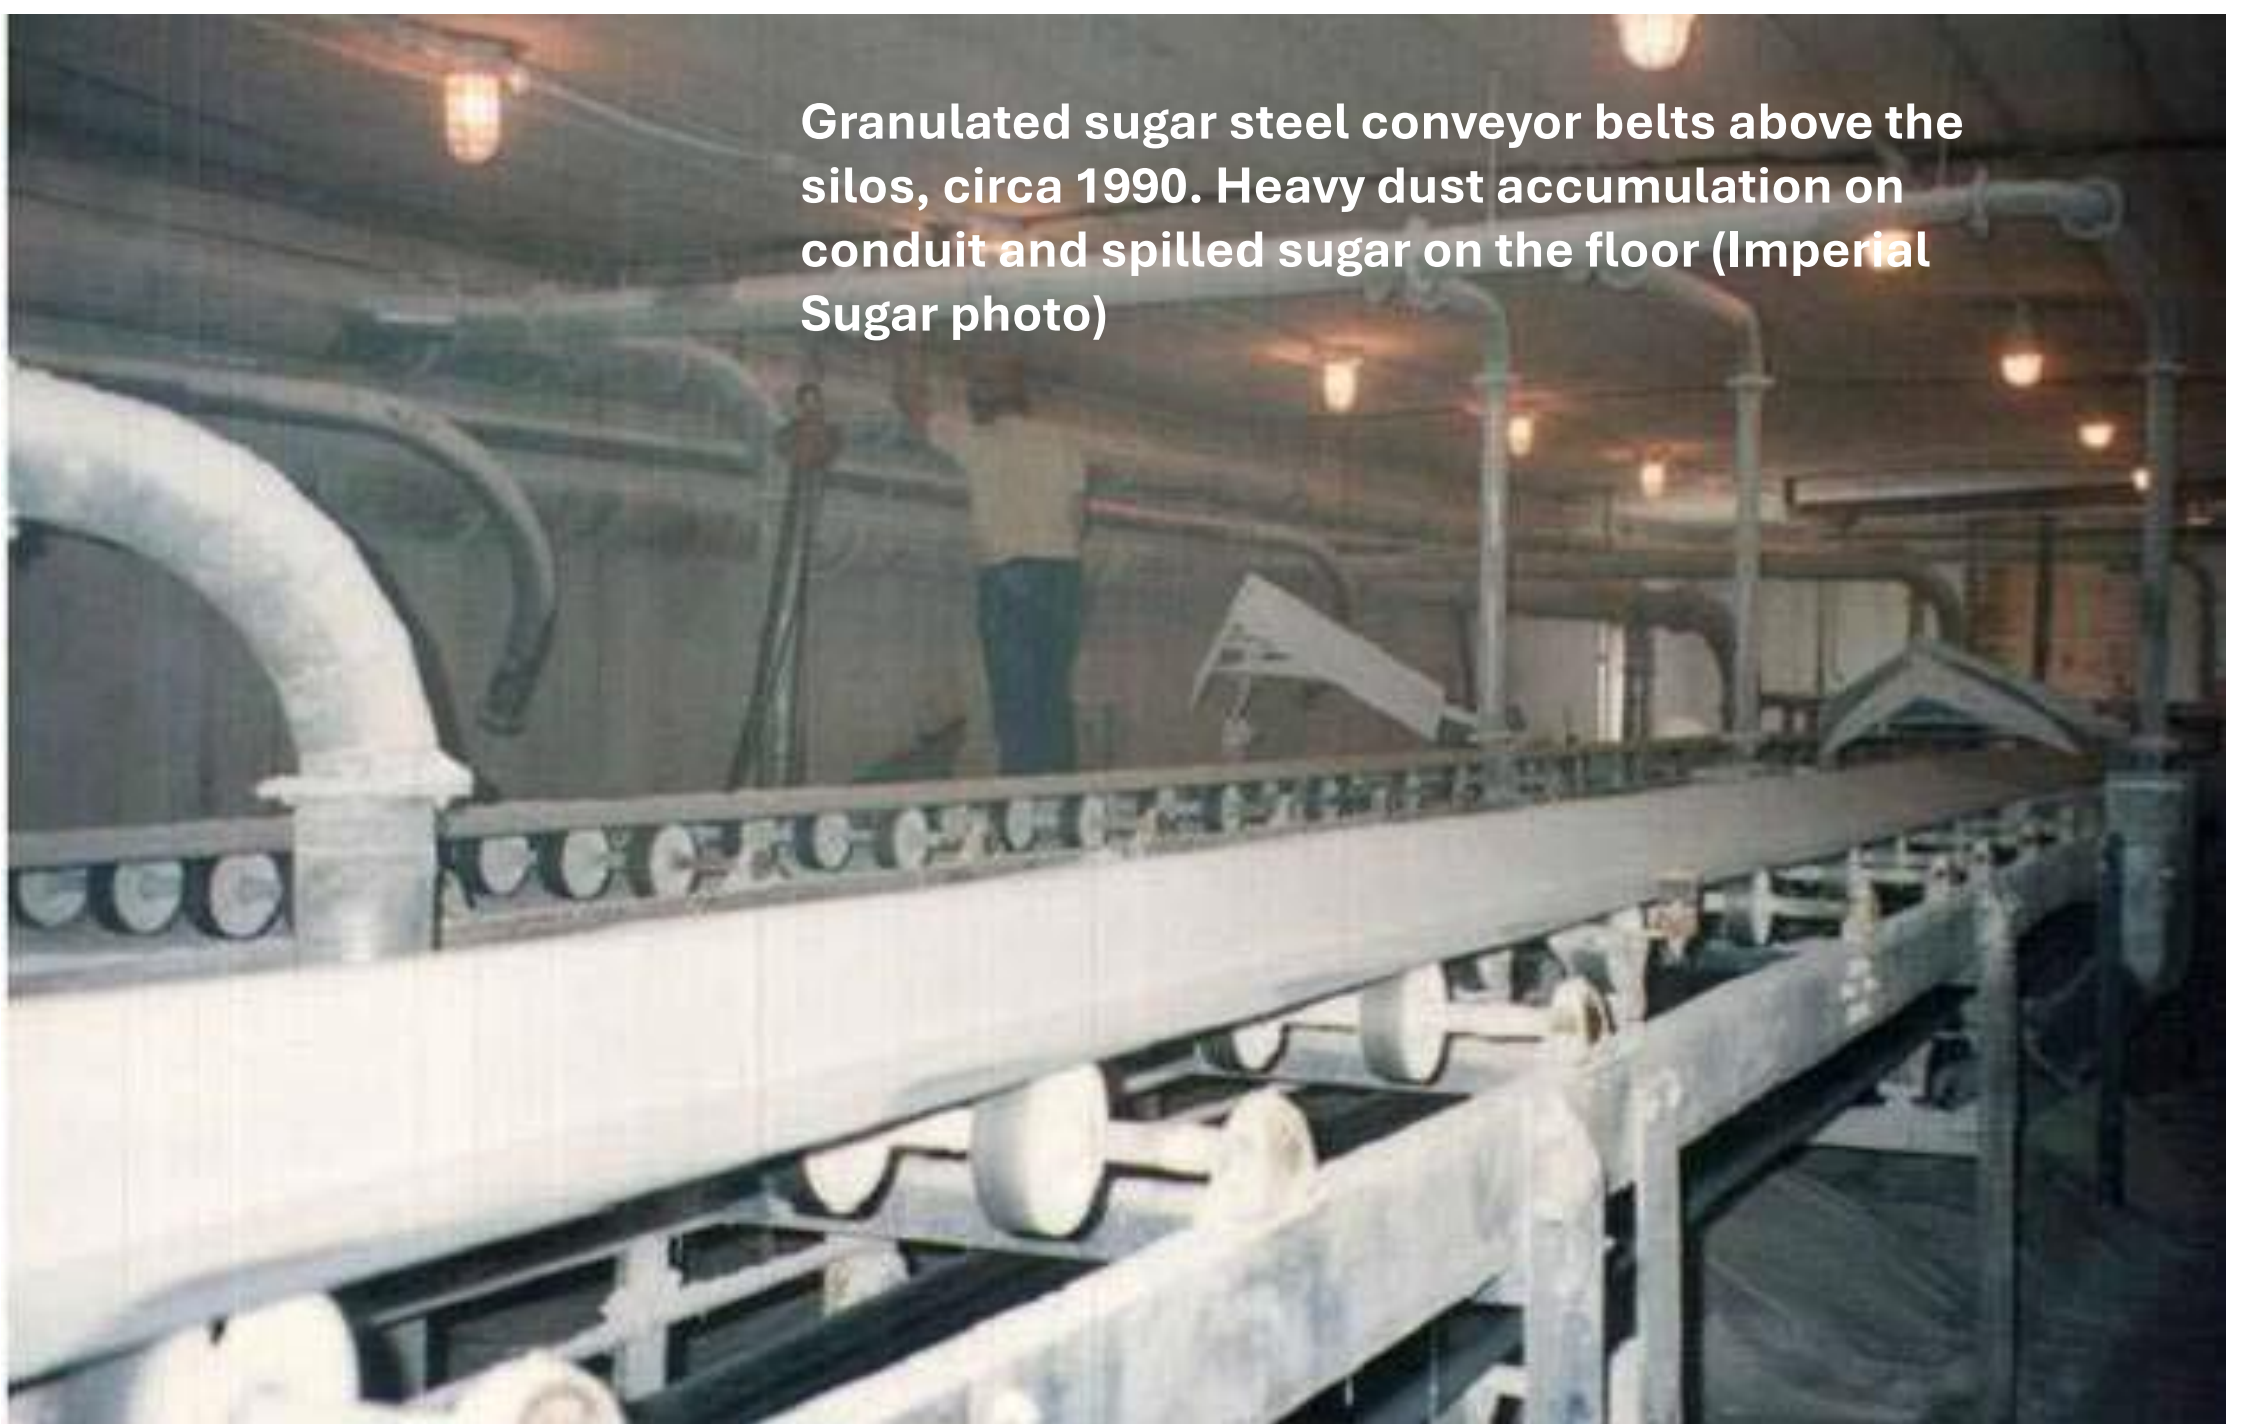
Granulated sugar steel conveyor belts above the silos, circa 1990. Heavy dust accumulation on conduit and spilled sugar on the floor (Imperial Sugar photo)

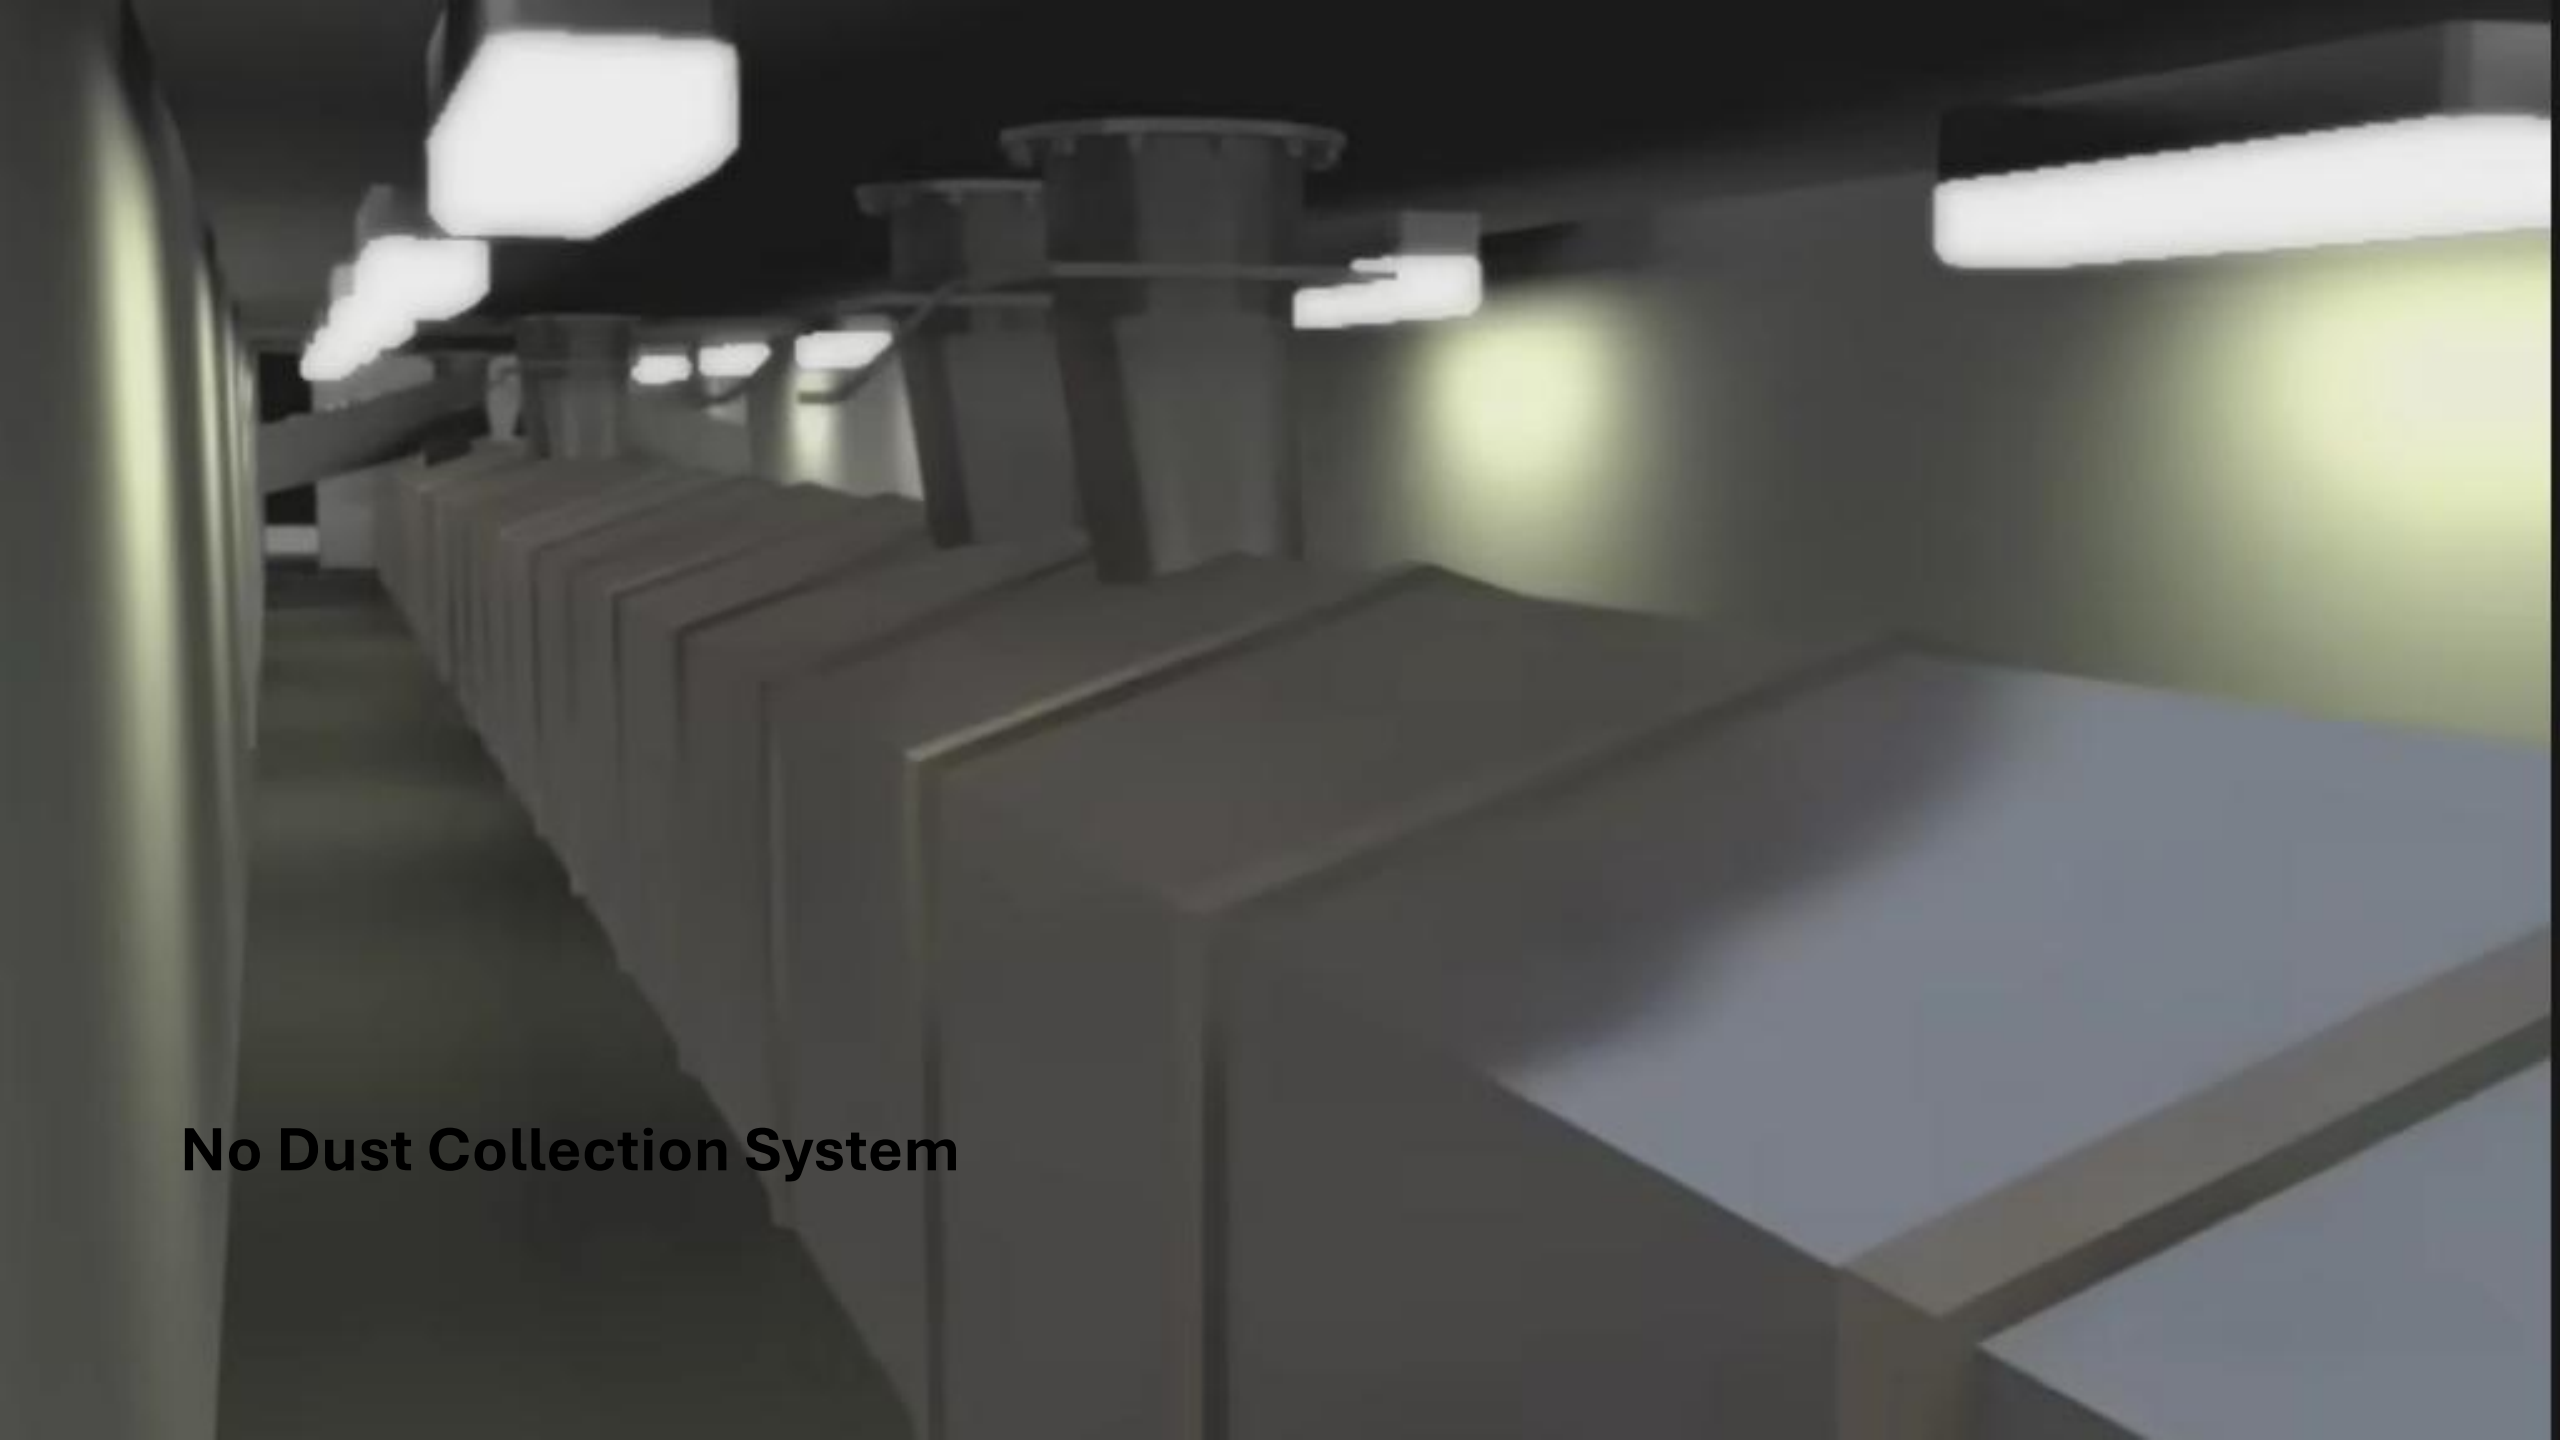
**Steel Sheilding
added in 2007**

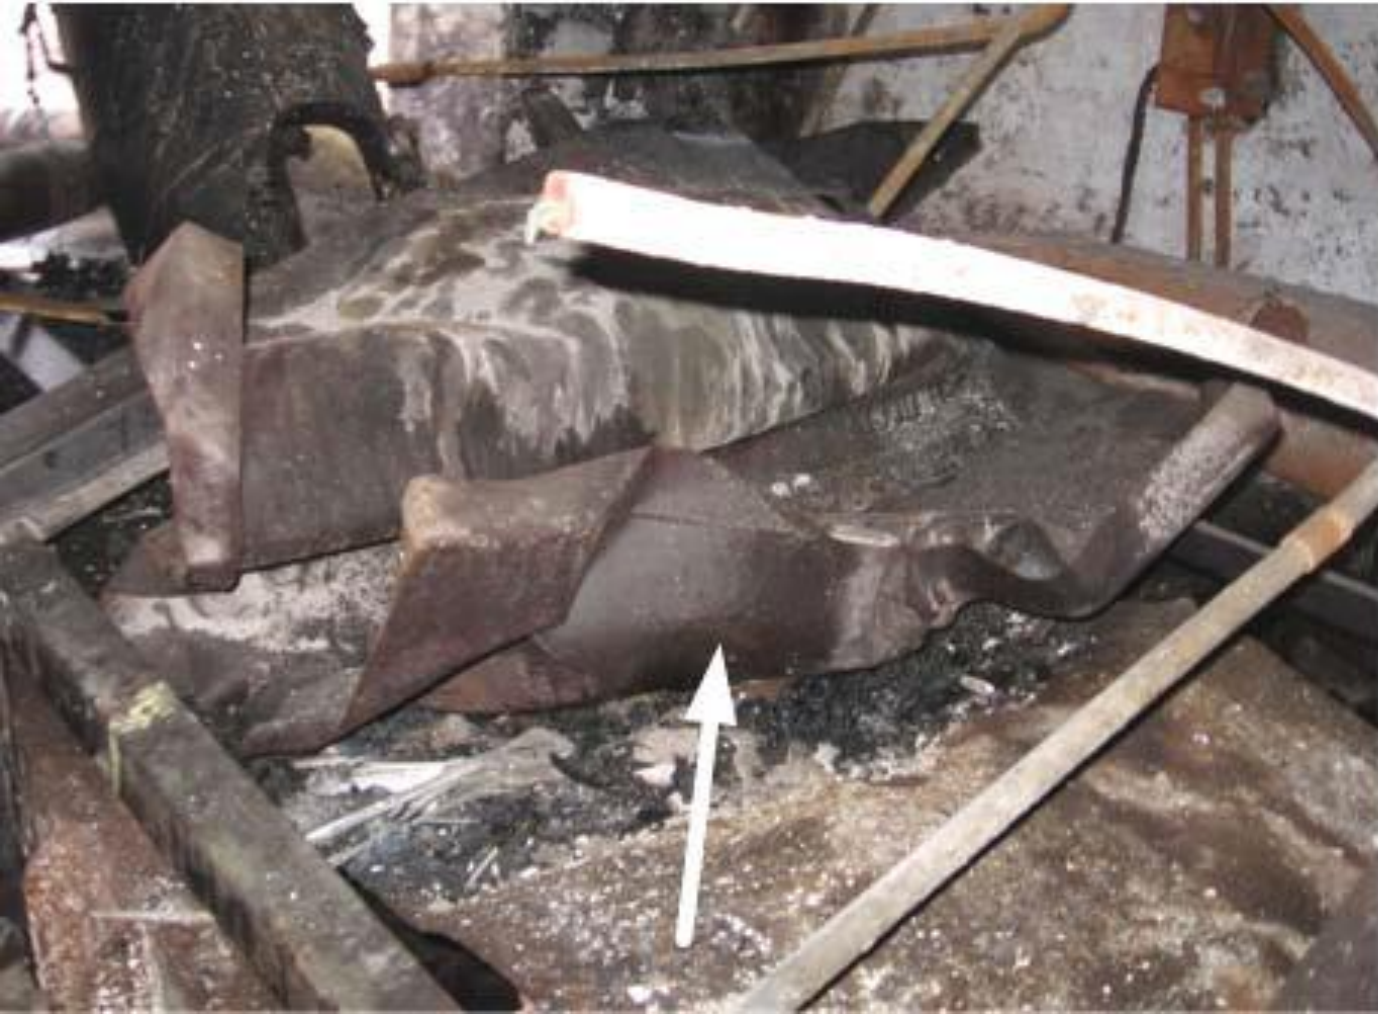
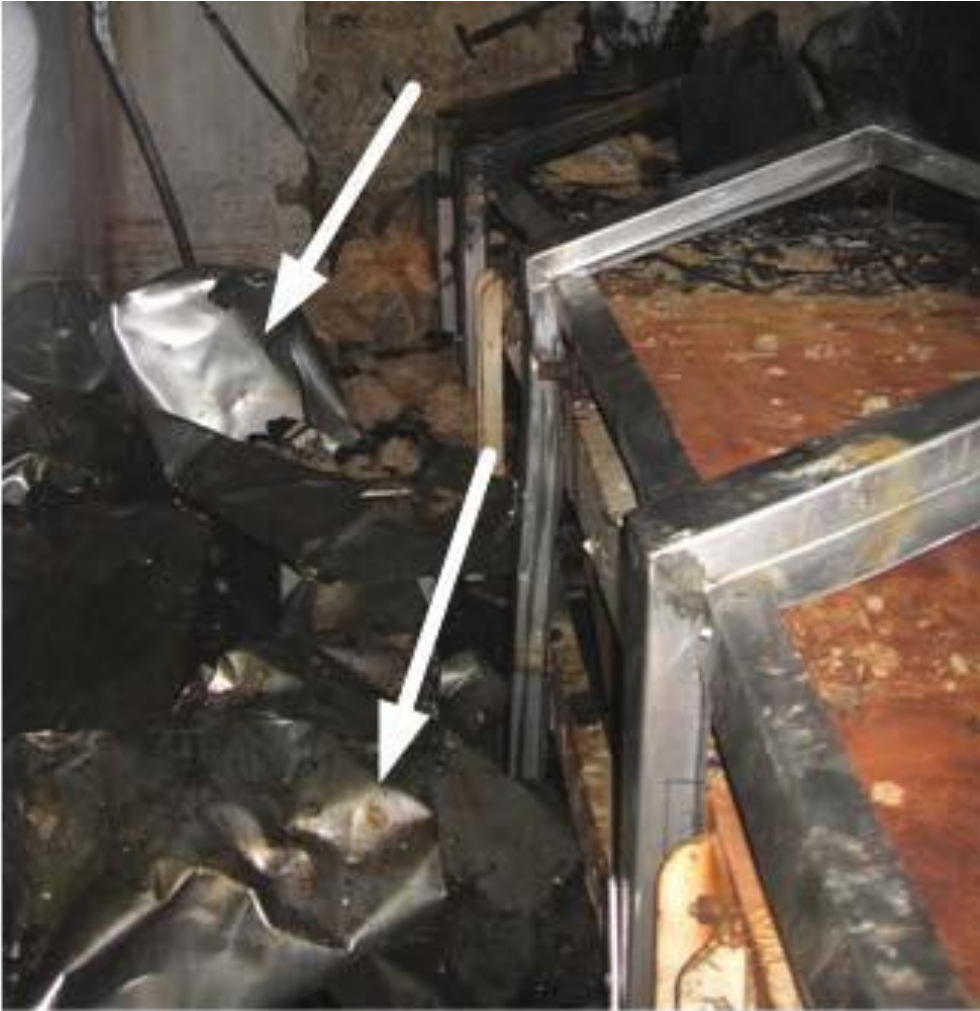
No Dust Collection System

Steel belt covers (arrows) crumpled from an initial dust explosion inside the steel belt enclosure (steel frame structure, right photo)
